GZA
GeoEnvironmental, Inc.

Re: Task 3 Dam Assessment - Final Report
Project #0-381
SRP Coronado Generating Station Evaporation Pond Dam
Apache County, Arizona

EXECUTIVE SUMMARY

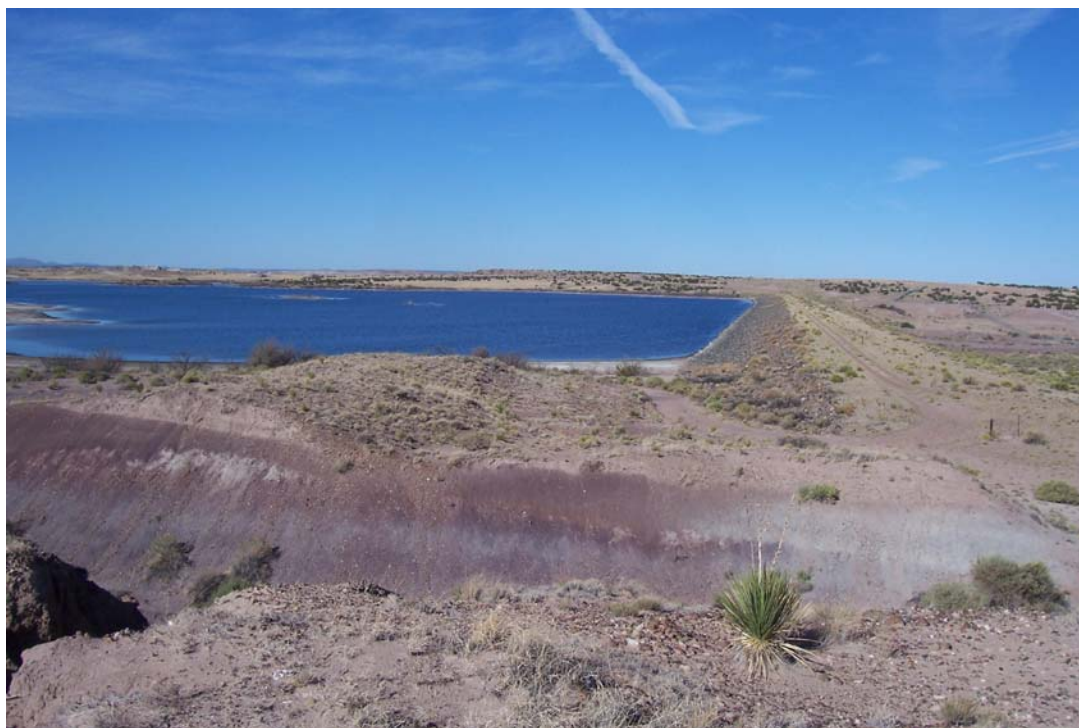
Photo 1: Overview of Evaporation Pond and Dam from right abutment. Note emergency spillway cut in foreground.

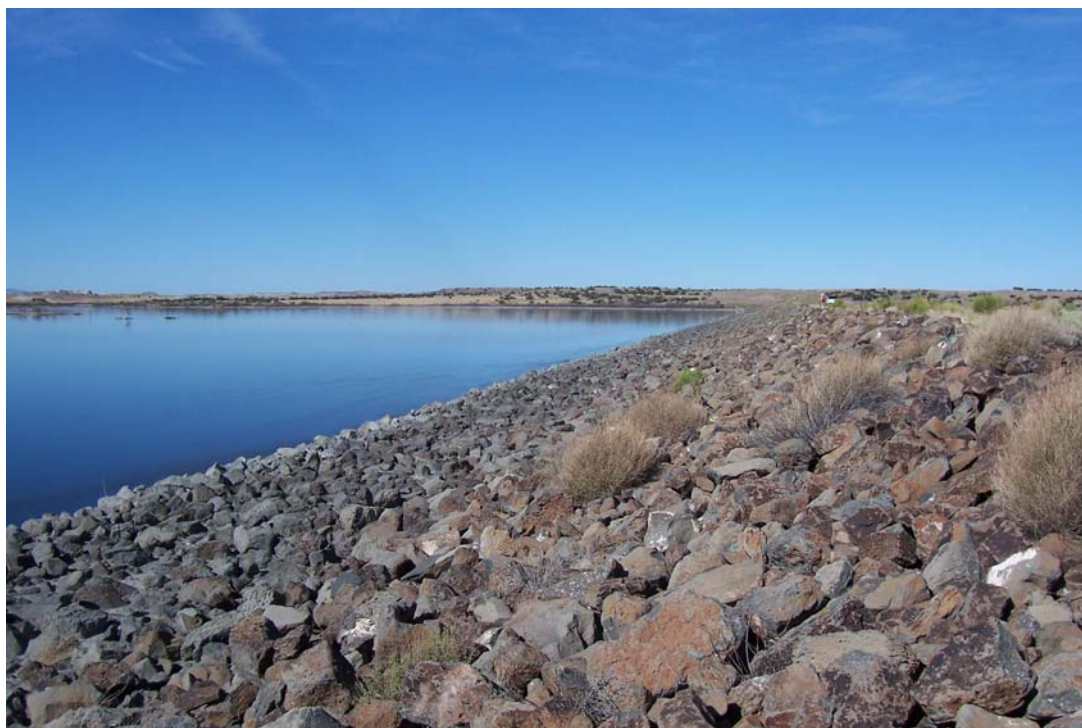
Photo 3: View along upstream riprap slope from right side of dam. Note upstream berm and lower portion of upstream slope submerged by Pond.

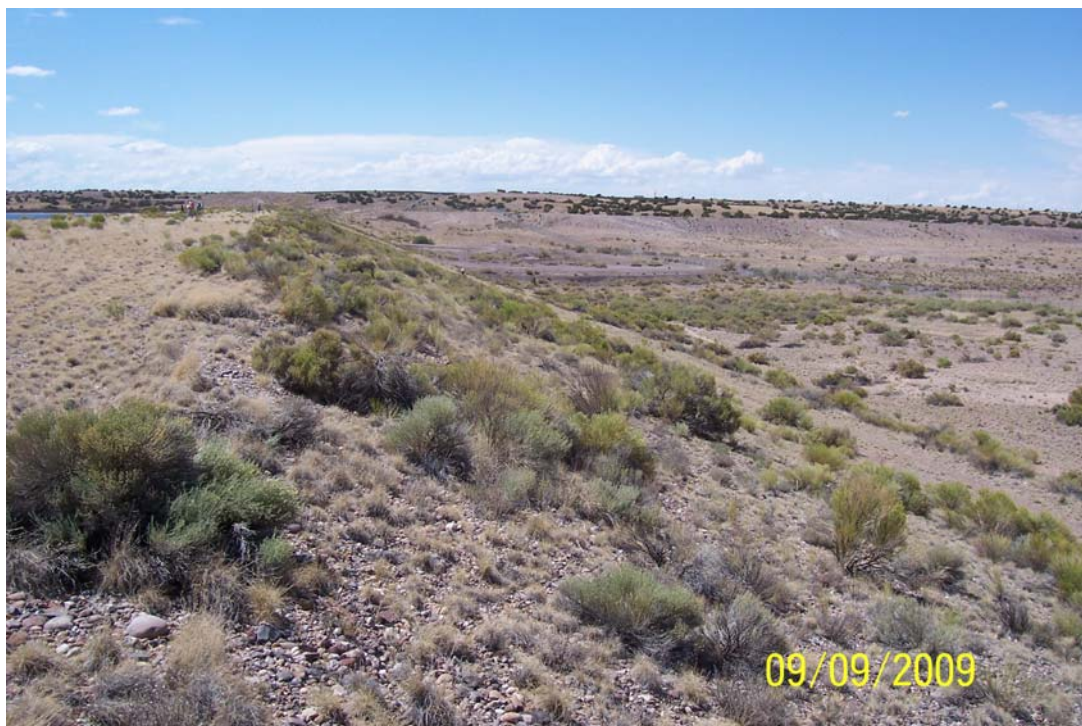
Photo 5: View along downstream slope of dam from right side of dam. Note gravel surface, and grass and brush vegetative cover.

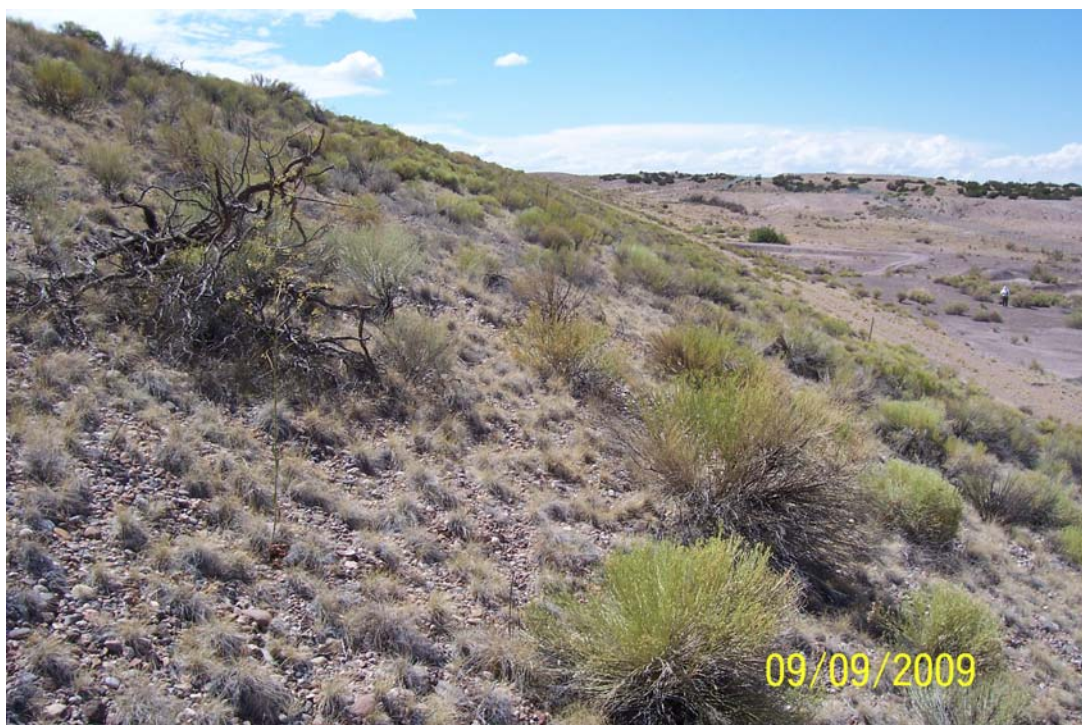
Photo 6: View along downstream slope of dam from right side of dam.

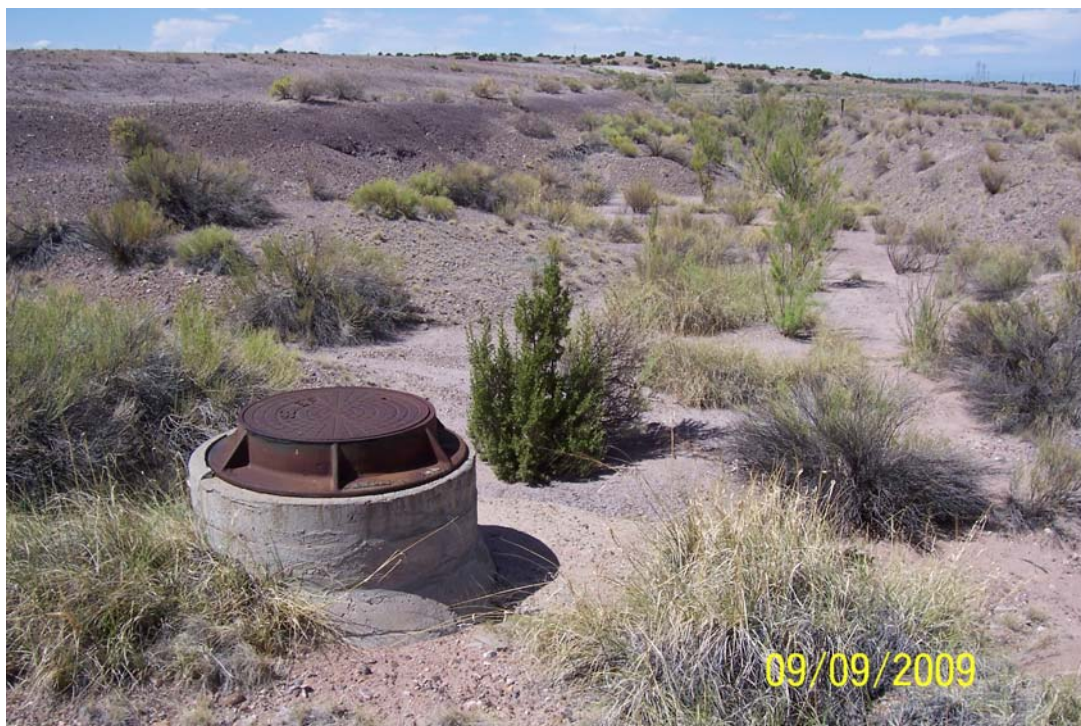
Additional erosion was observed at the toe of the downstream slope, especially to the right of the left toe drain manhole, where surface runoff appears to be eroding a channel in the secondary containment berm. Some minor to moderate erosion was observed on the slopes adjacent to the left and right toe drain manhole (Photos 9 and 10) and on the containment berm.

Photo 9: View of right toe drain manhole at downstream toe of dam. Note dry discharge channel surrounded by secondary containment berms

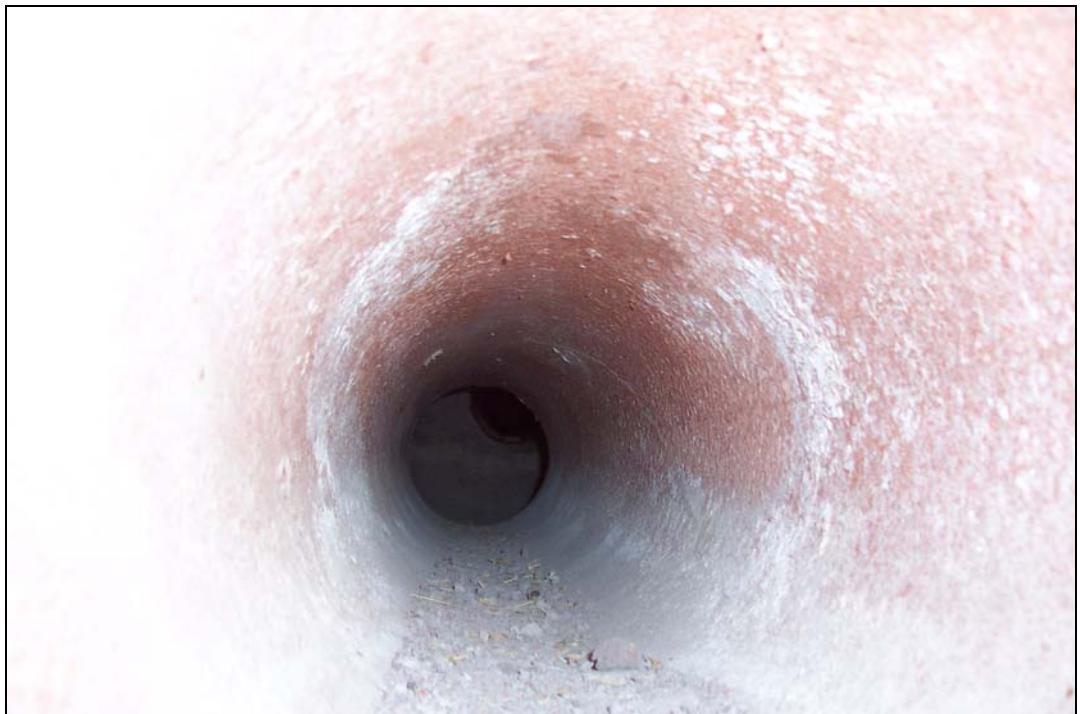
Photo 12: View through vitrified clay outlet pipe from downstream. Right toe drain manhole and toe drain collection pipe visible in background.

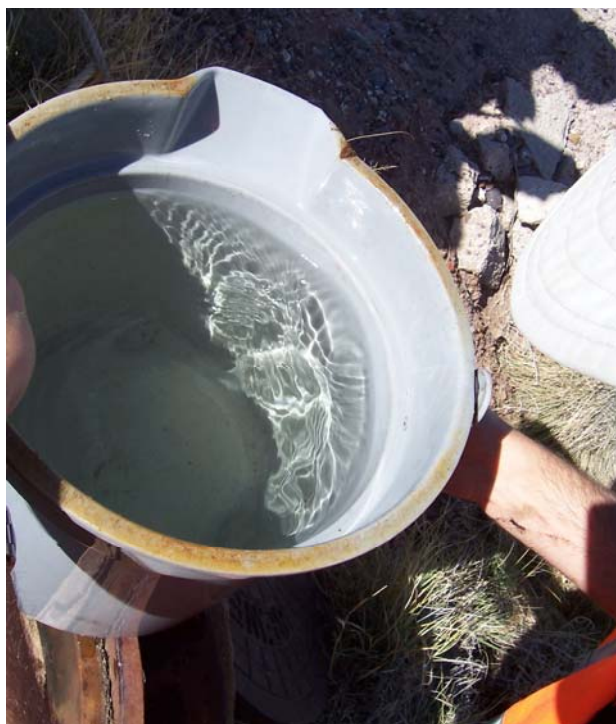
Photo 16: View of seepage water taken from left toe drain manhole.

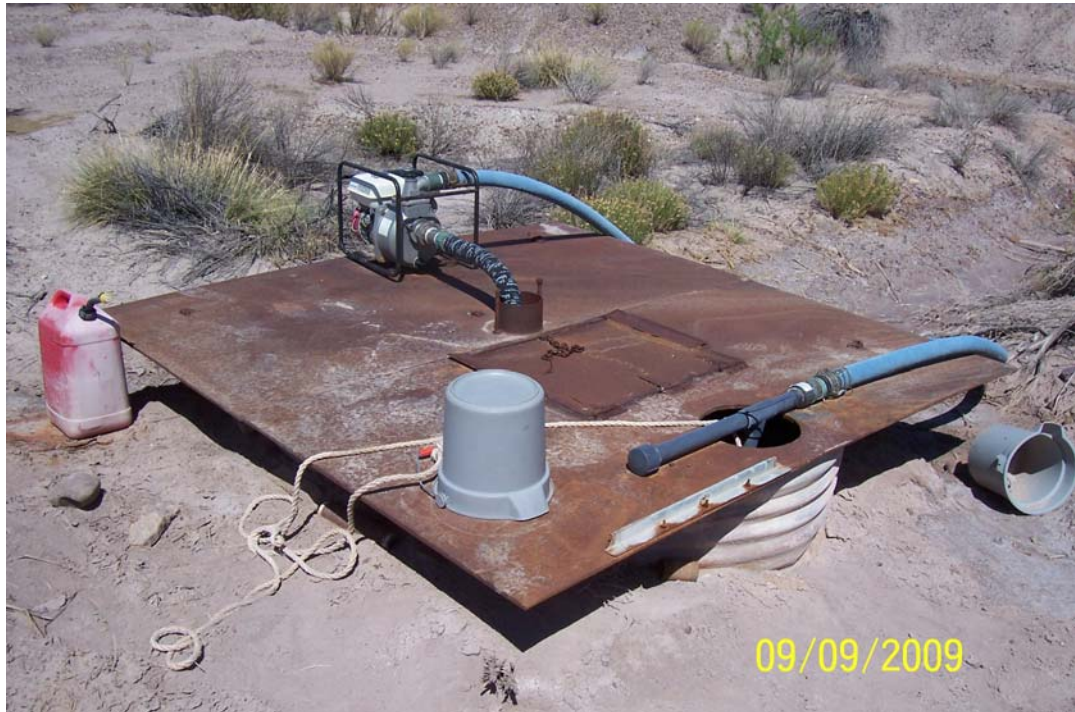
Photo 17: View of left toe drain sump, with gas pump, recirculation piping, and bucket used for flow measurement and seepage observations.

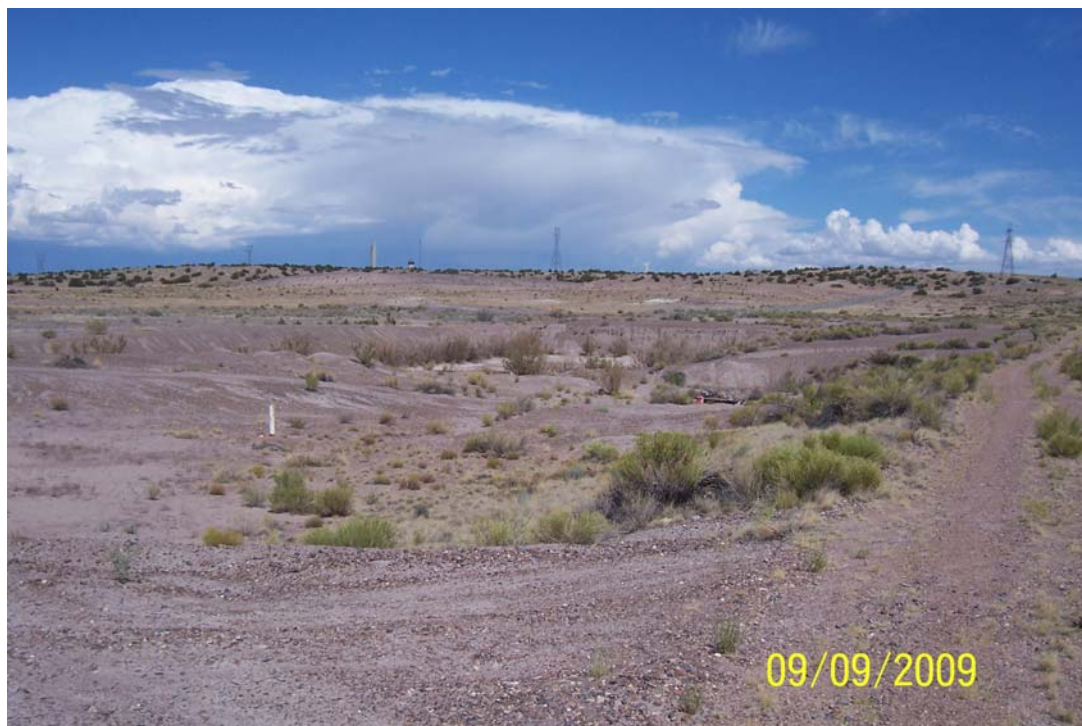
Photo 19: Overview of downstream area, with secondary containment berms visible for containment of seepage discharge.

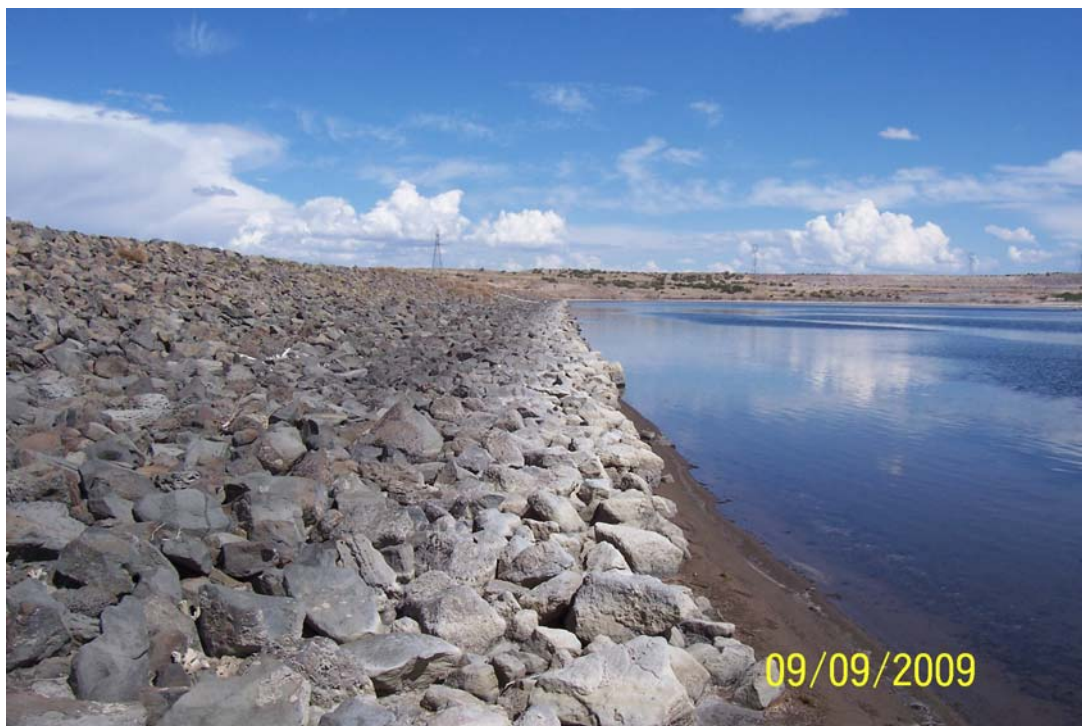
Photo 23: View along upstream slope of dam from left side. Note upstream berm partially visible above water line.

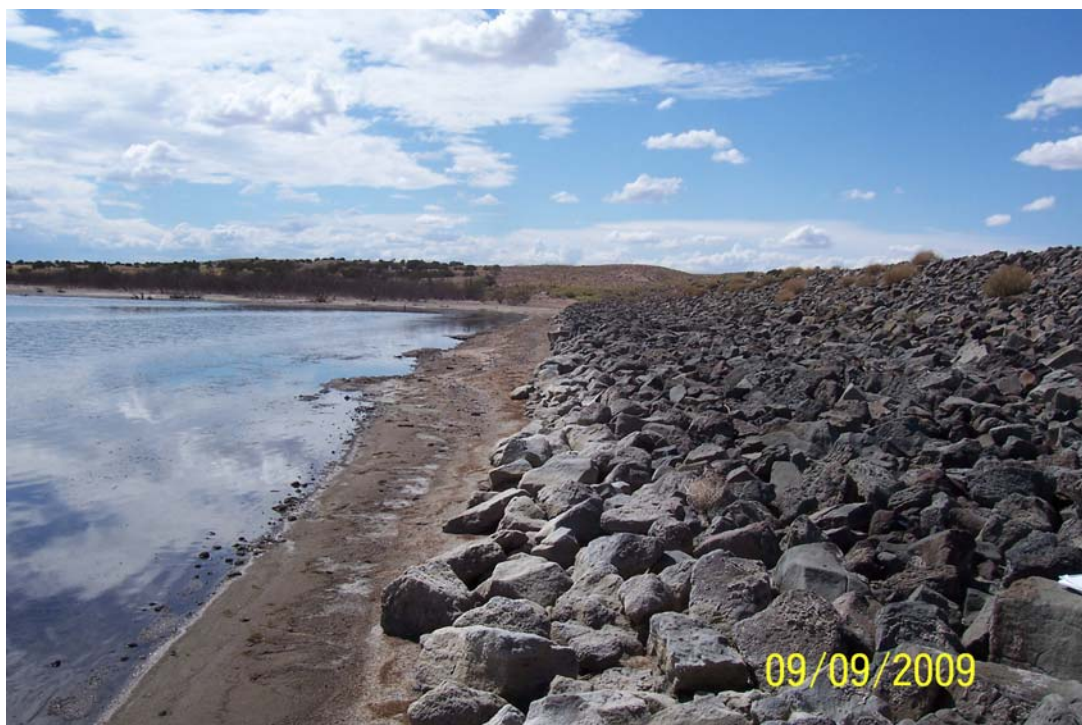
Photo 24: View along upstream slope of dam looking towards left abutment.

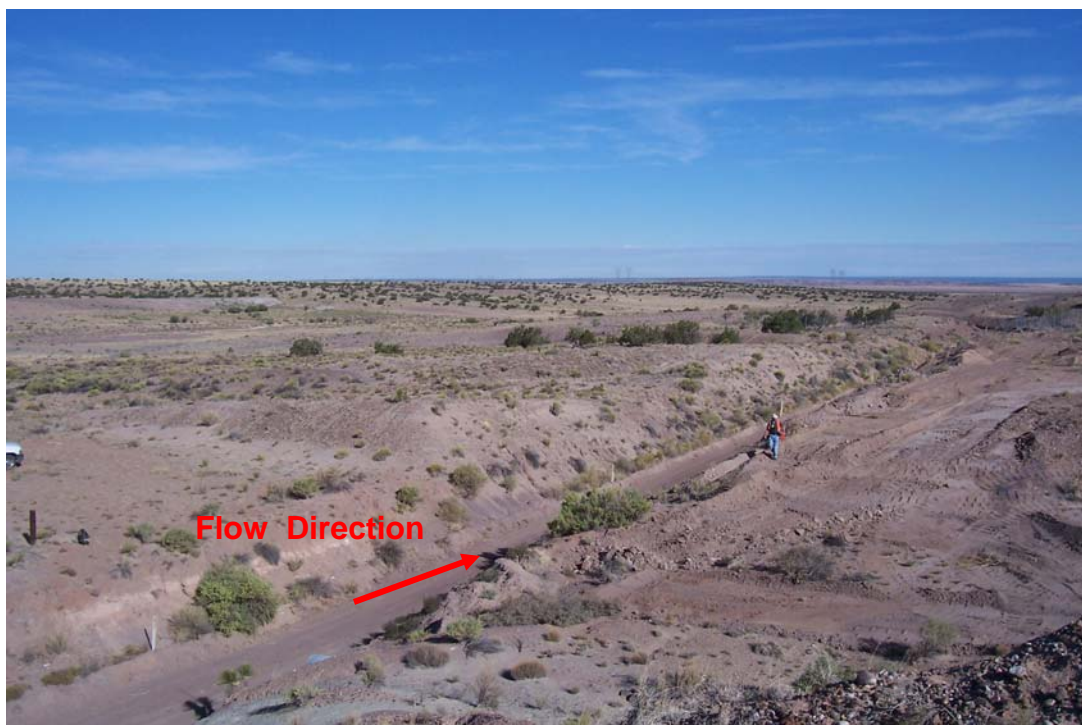
Photo 30: Overview of emergency spillway channel from top of right channel slope. Channel invert in foreground, discharge area in background.

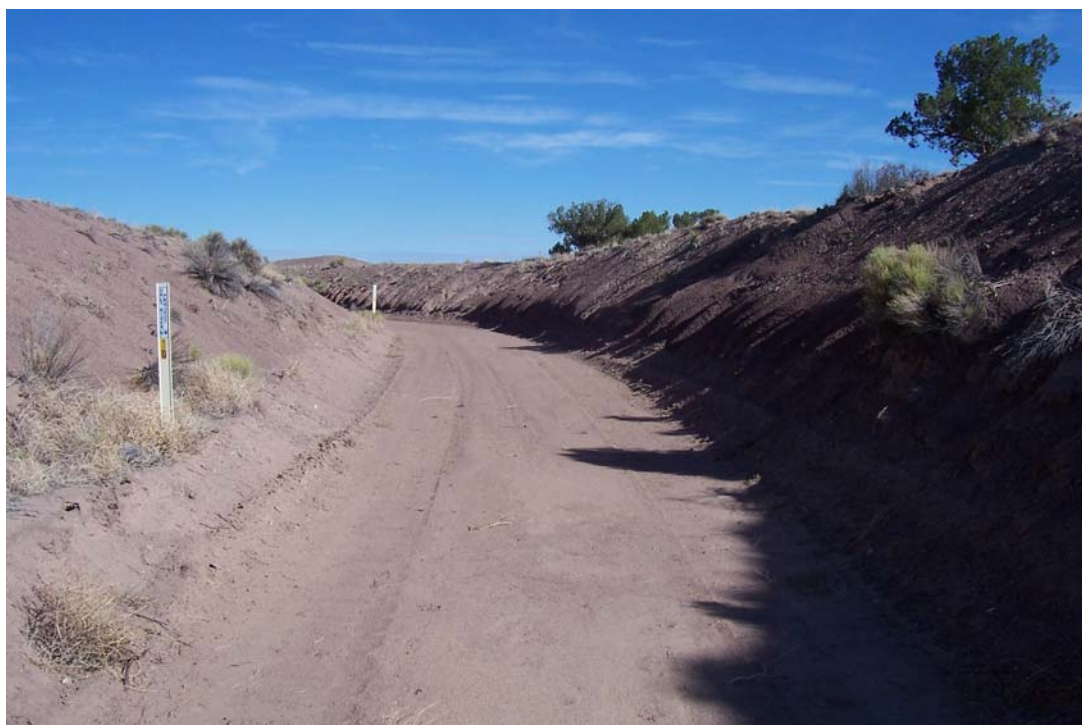
Photo 32: View within emergency spillway channel, looking downstream towards discharge area. Note recent grading of spillway channel bottom.

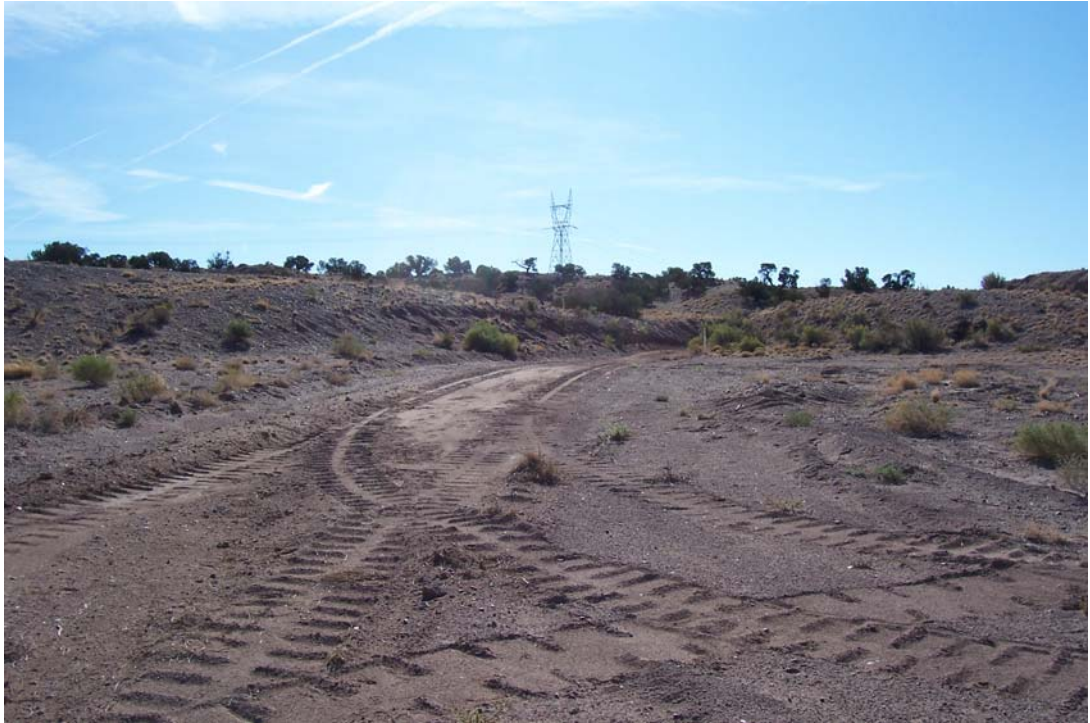
Photo 33: View of emergency spillway discharge area from downstream.

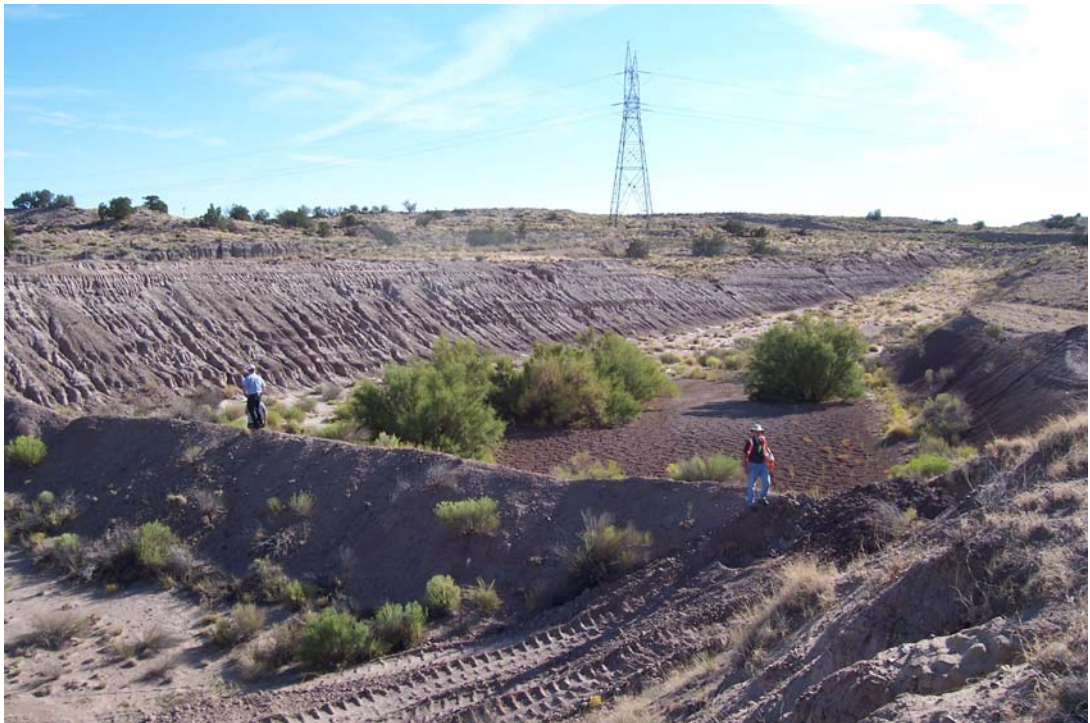
Photo 34: View of excavated area at right abutment, with earthen berm constructed to prevent stormwater runoff from eroding spillway slopes.

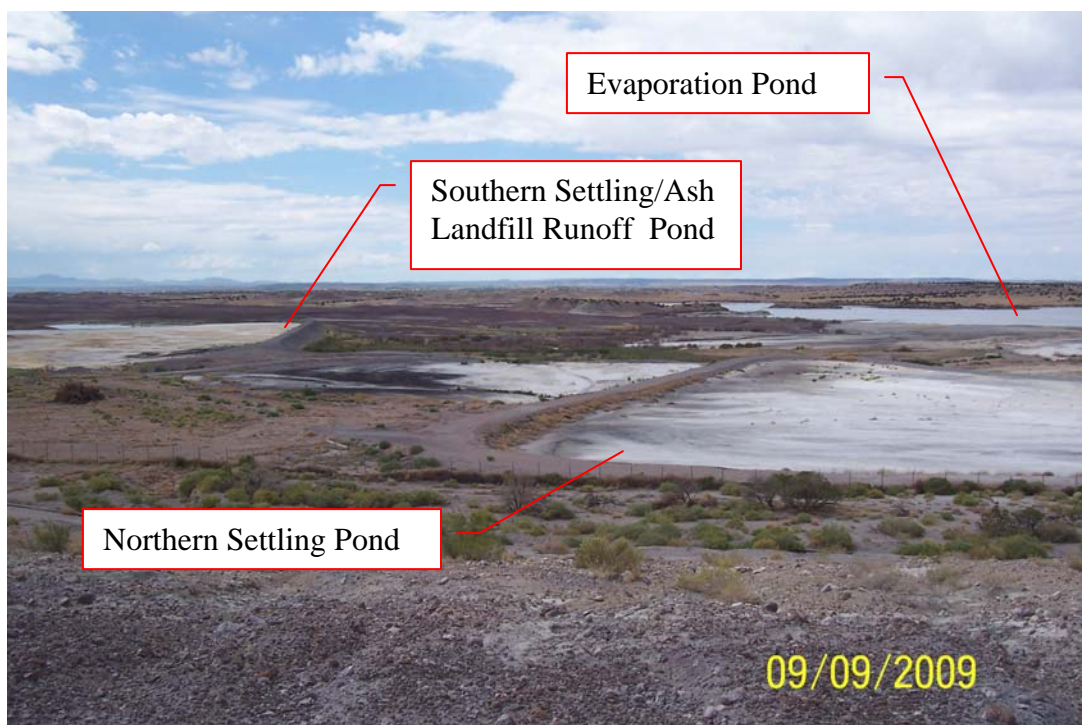
Photo 40: View from Ash Landfill area towards settling ponds and Evaporation Pond.
